**SAS Superstructure**

Daily Diary Report by Bid Item

Contract No.: 04-0120F4

Diary #: 405 Const Calendar Day: 128 Date: 10-Oct-2012 Wednesday

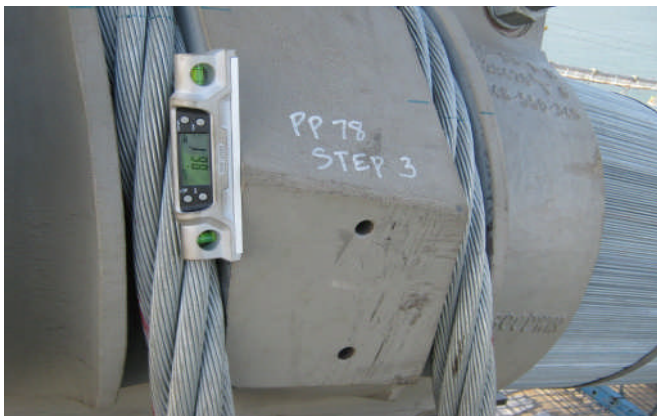
- At 15:00, Kevin Karber's crew started to sort stanchion posts for the South side-span to get ready to start installing them.
- From 16:30 until 17:00, I took some measurements of the angles of the CB troughs with a digital level. They should be 90 degrees (plumb along the centerline of bridge direction). The angle of the CB trough varied up to 4 degrees, with the largest variations from plumb occurring at the same CBs where there is an issue with the suspender ropes pressing hard against the CB trough at the exit point. I took photos of each angle measurement. See attached photo.

CB trough angle of 86 degrees at PP78S (should be 90 degrees in this

direction)

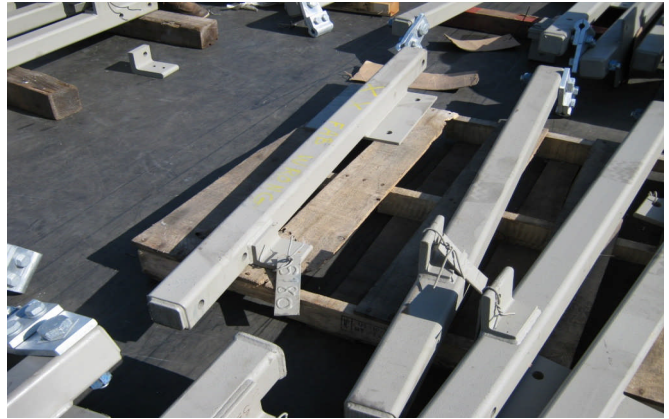
- From 07:25 until 10:00, Gary's crew was sorting stanchion posts.
- Note: The iron-workers noticed that the outboard stanchion post at PP18S was not fabricated correctly. The MEP attachment plates were welded onto the wrong side of the stanchion post. If installed in its current condition, the MEP attachment plates would be perpendicular to the intended position. See attached photo. The plates need to be removed & then re-welded at their correct position. I notified Roman Granados of this, & we looked up the shop drawings for this post, & gave a copy of them to lead METS inspector Rodney Patterson since METS will need to inspect the re-welding.

Stanchion post at PP18S that was fabricated with the MEP plates on the wrong side of the post

- From 12:30 until 13:30, Gary's crew was sorting stanchion posts & installing the hand rope clamps at the top of the stanchion posts.
- At 13:20, the painters took the stanchion post at PP18S to be blasted to remove the paint prior to the re-welding work.
